AFWAL-TR-88-4254

FATIGUE CRACK GROWTH-MICROSTRUCTURAL
RELATIONSHIP OF Ti-6Al-4V

STEVEN R. THOMPSON
Materials Engineering Branch
Systems Support Division

November 1988

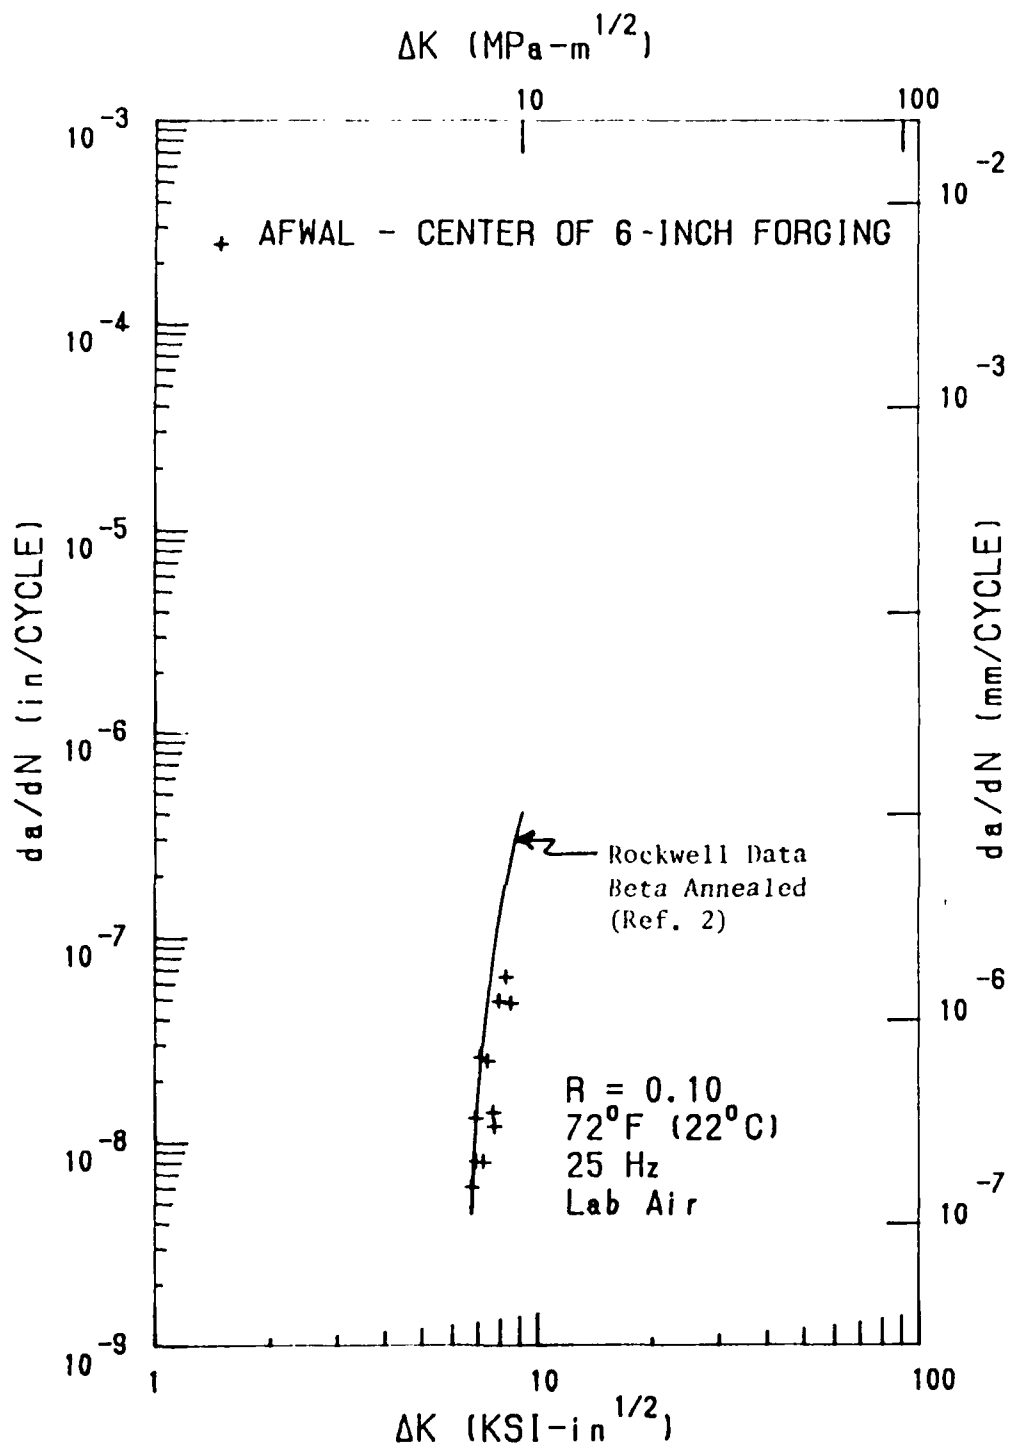
Figure 5. FCGR results for specimen removed from the center of a six-inch forging and reference data for a two-inch-thick Beta-Annealed forging.

FCGR data from the original program was replotted against the data from Chesnutt and Wert for each stress ratio; heat treatment and location in the forgings were the variables. The comparisons of these two sets of data are shown in Figs. 5-8. From these curves the variation of FCGR could be correlated to the published data of Rockwell for a given stress ratio and a given microstructure for all cases. The fatigue crack growth rates, Fig. 8, for beta-quenched microstructure at $R=0.7$ was marginally slower than the data reported by Rockwell. This can

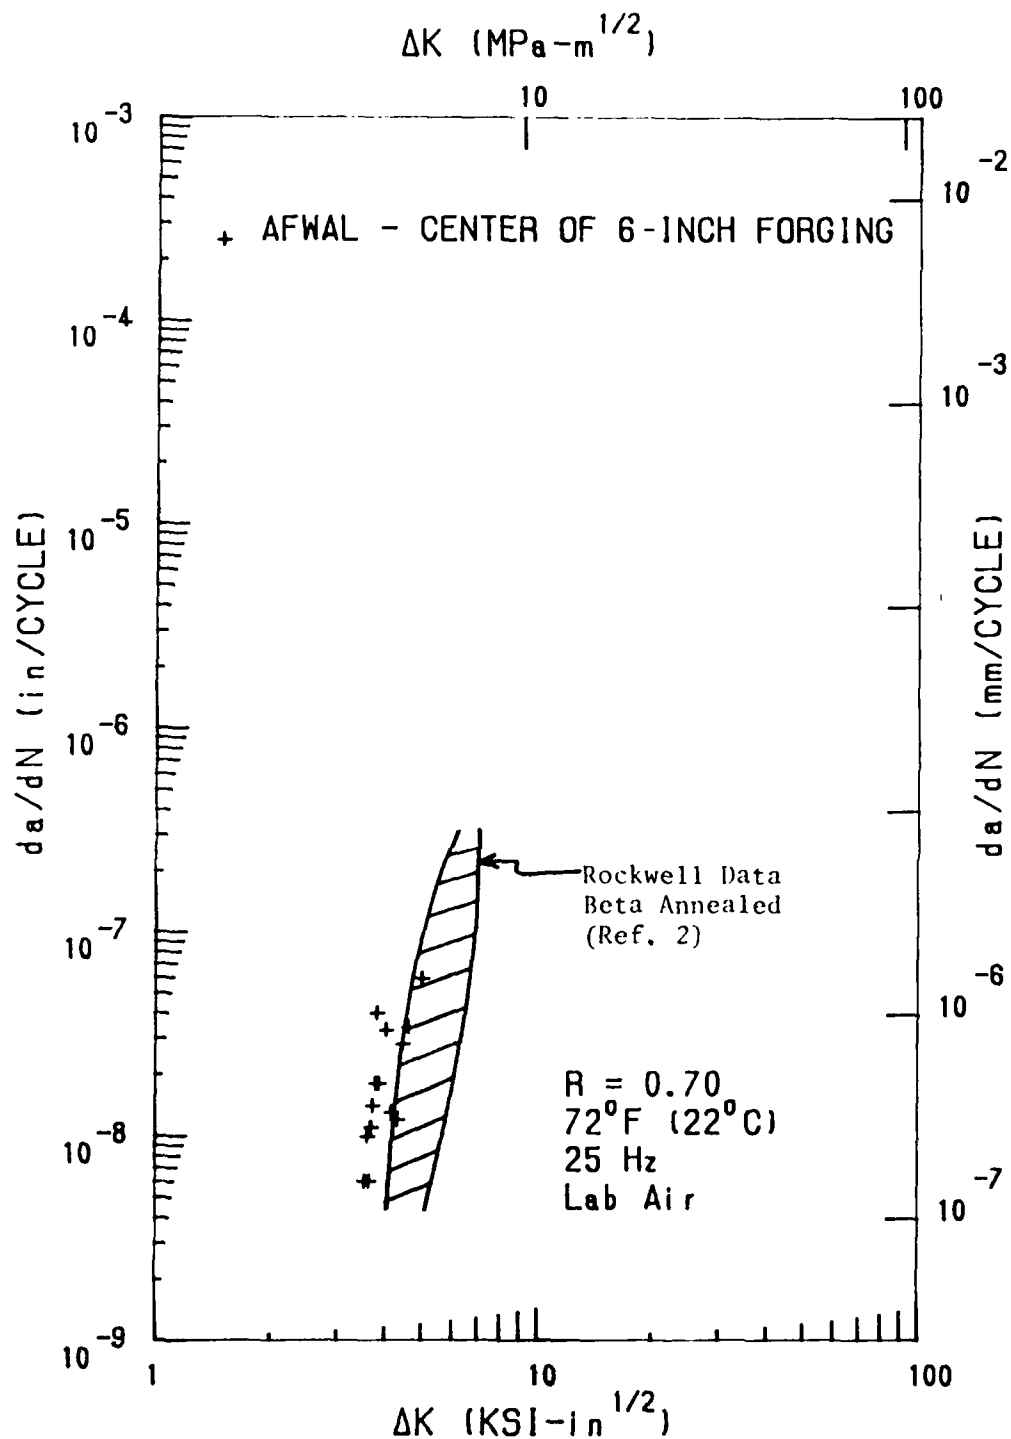
Figure 6. FCGR results for specimen removed from the center of a six-inch forging and reference data for a two-inch-thick Beta-Annealed forging.

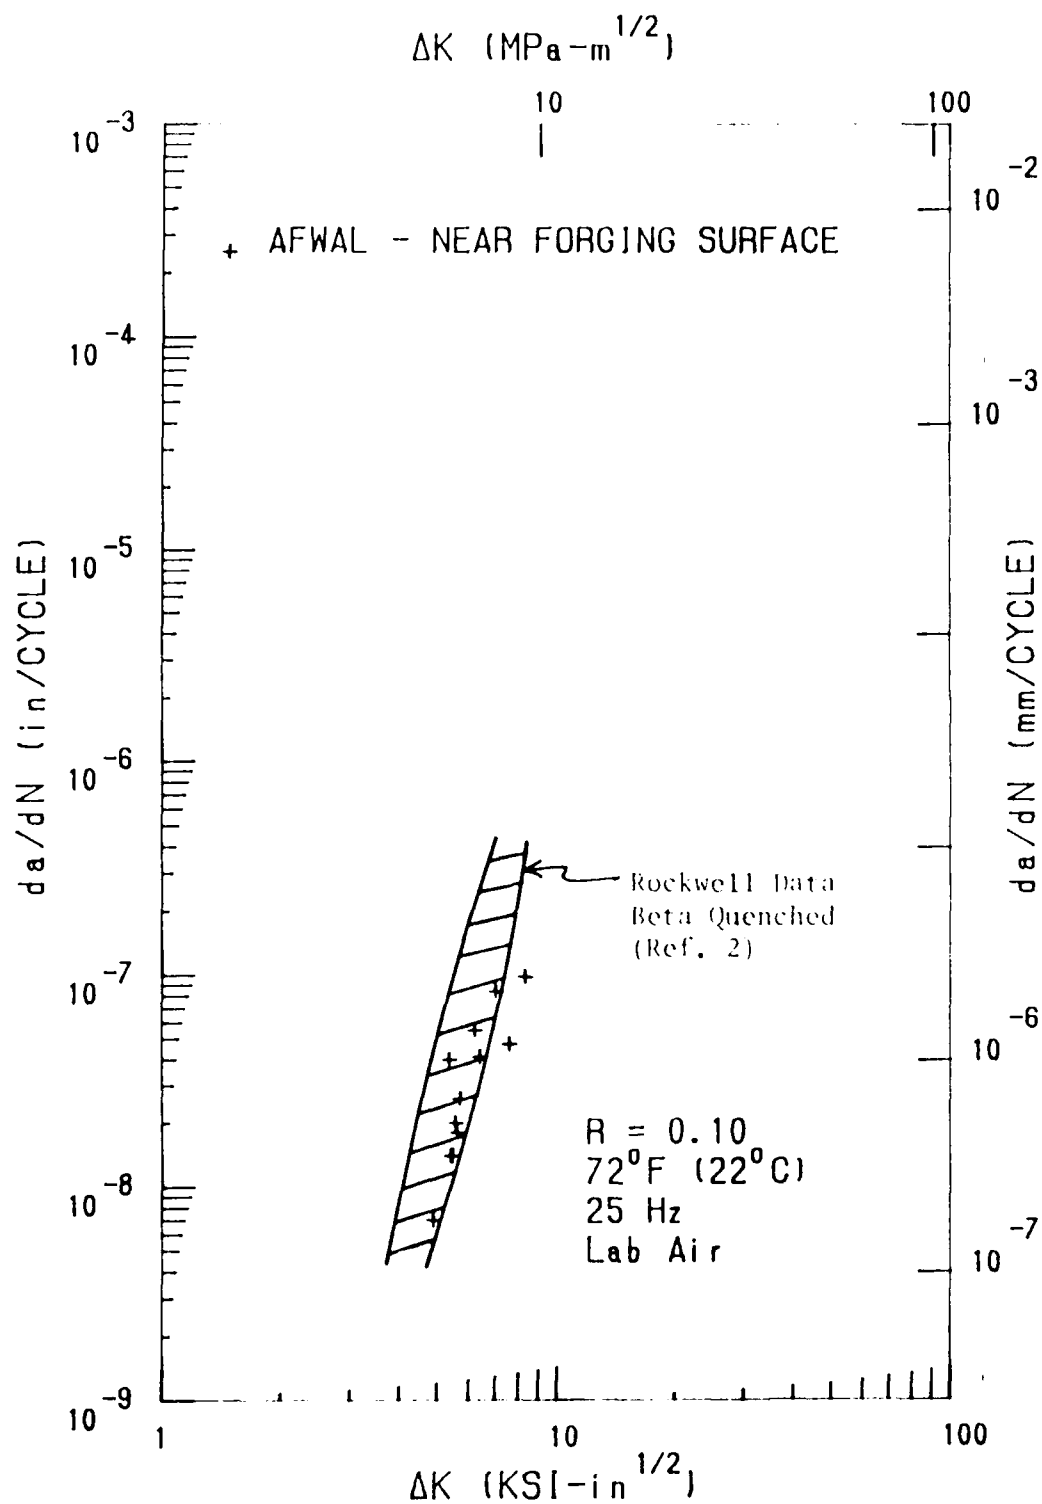
Figure 7. FCGR results for specimen removed from near the surface of a six-inch forging and reference data for a two-inch-thick Beta-Quenched forging.

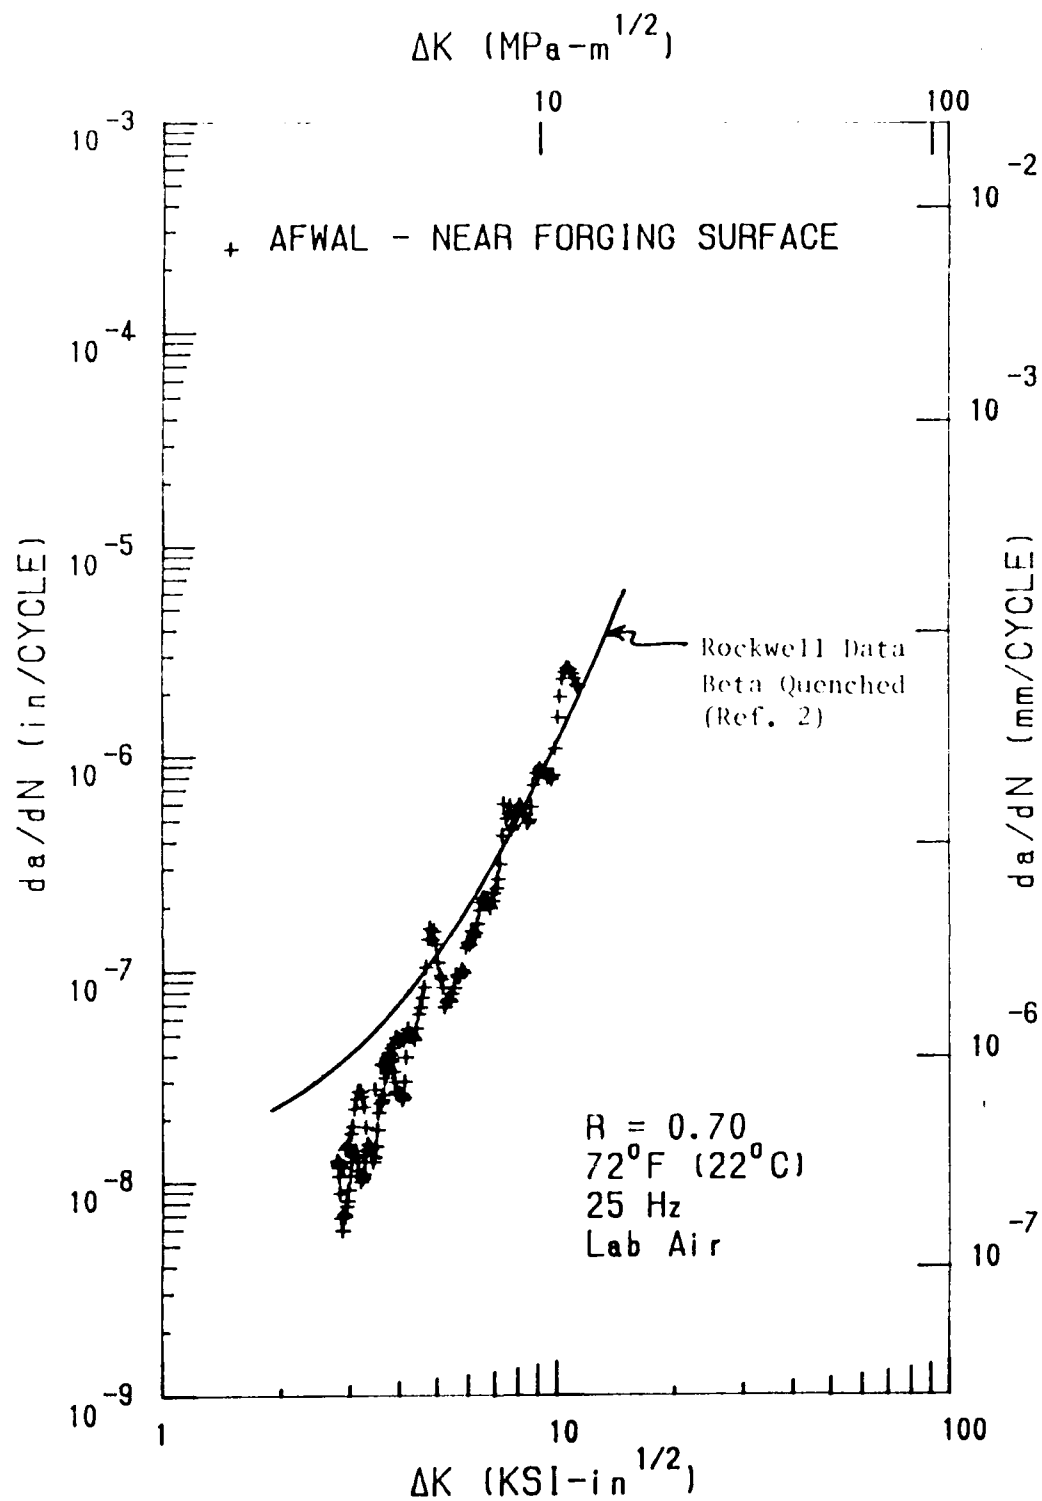
Figure 8. FCGR results for specimen removed from near the surface of a six-inch forging and reference data for a two-inch-thick Beta-Quenched forging.

be attributed to the fact that the location the specimen was removed from in the forging was about an inch away from the surface. This location allowed for a small growth in the size of the alpha platelets. These platelets, however, had not grown sufficiently enough for the microstructure to be called beta-annealed. Due to the large number of data points for this specimen, a seven point incremental data reduction routine was used. These points are the ones shown in Fig. 8. The AFWAL FCGR curves shown in Figs. 5, 6, and 7 are curves that were previously reported (1). The data in Fig. 8 was produced during this current effort.
